**LETTER REPORT
FOR
CELOTEX SITE
WILMINGTON, WILL COUNTY, ILLINOIS
TDD: S05-9903-018
DAN. QM1801SIXX**

June 28, 1999

Subject: Celotex Site
Wilmington, Will County, Illinois
TDD: S05-9903-018
PAN: 9M1801SIXX

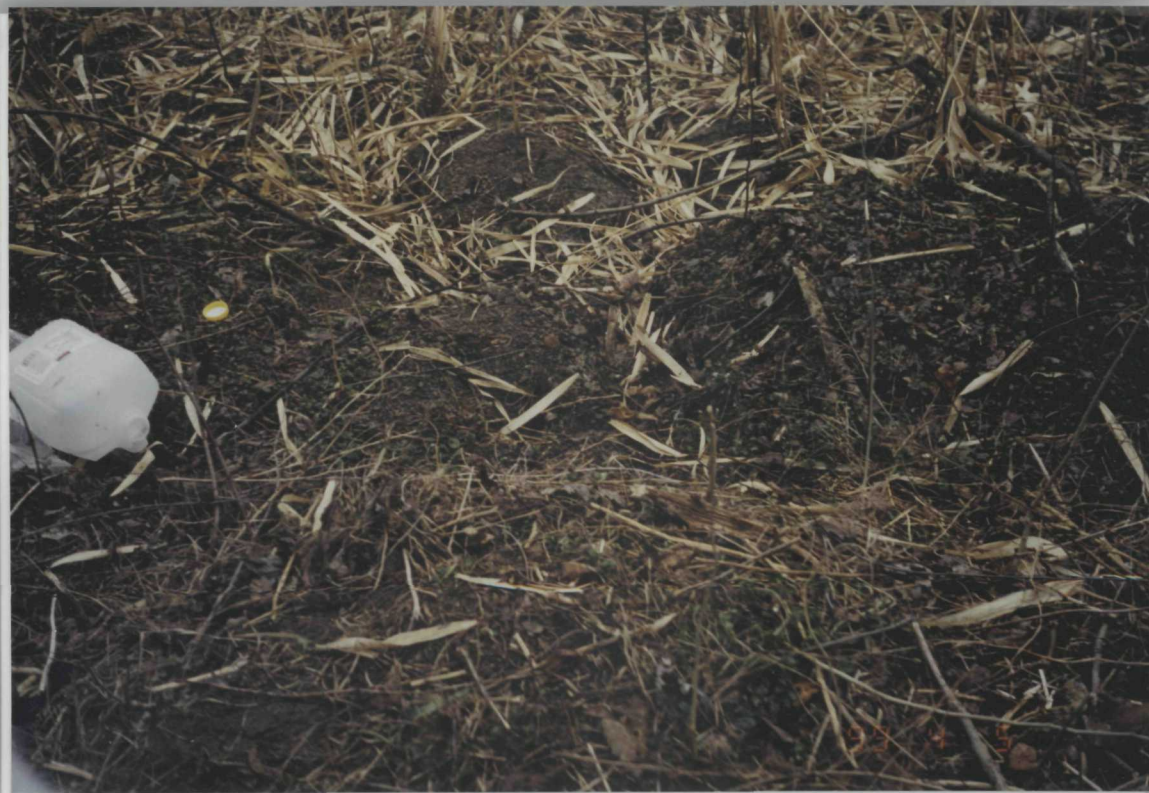
Site: Celotex
Location: Wilmington, IL
Subject: Perspective of sample DEP-1 location.

Date: April 5, 1999
Direction: Southeast

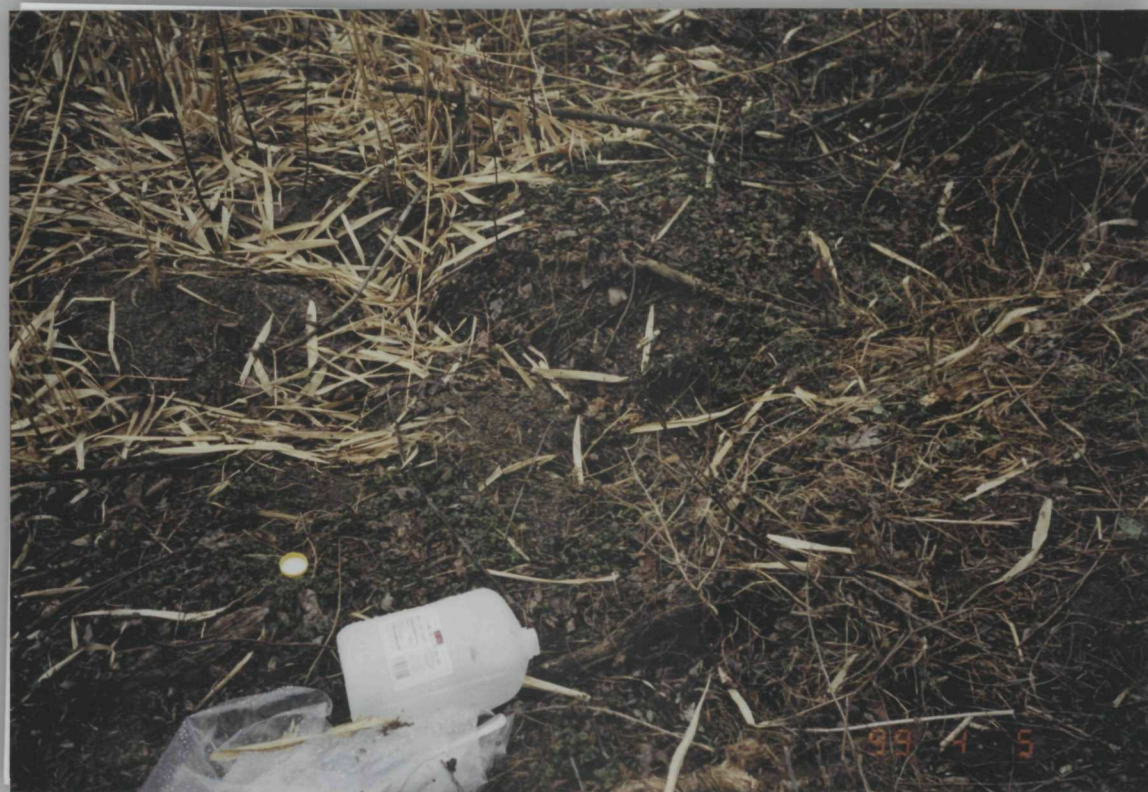
Site: Celotex
Location: Wilmington, IL
Subject: View of sample DEP-1 location.

Date: April 5, 1999
Direction: East

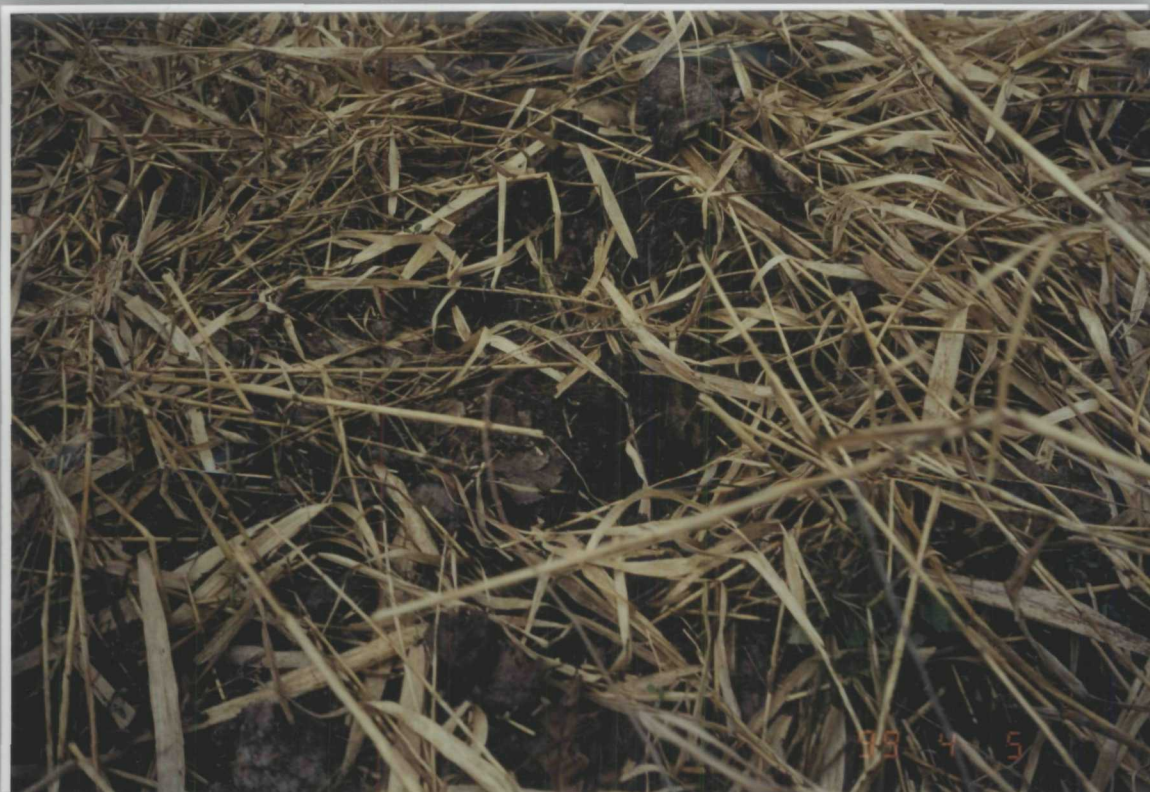
Site:	Celotex	Date:	April 5, 1999	Time:	1502
Location:	Wilmington, IL	Direction:	East	Photographer:	R. Nagam
Subject:	View of sample DEP-2 location.

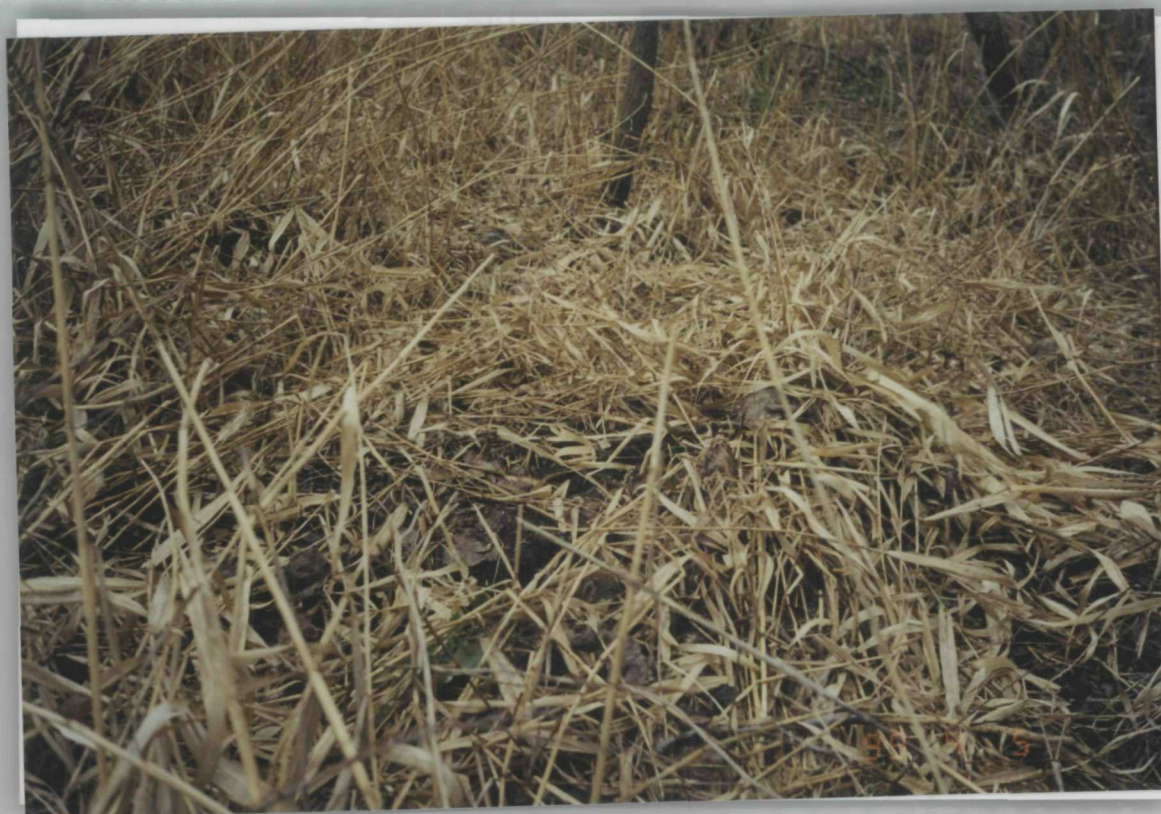
Site:	Celotex	Date:	April 5, 1999	Time:	1502
Location:	Wilmington, IL	Direction:	Southeast	Photographer:	R. Nagam
Subject:	Perspective of sample DEP-2 location.

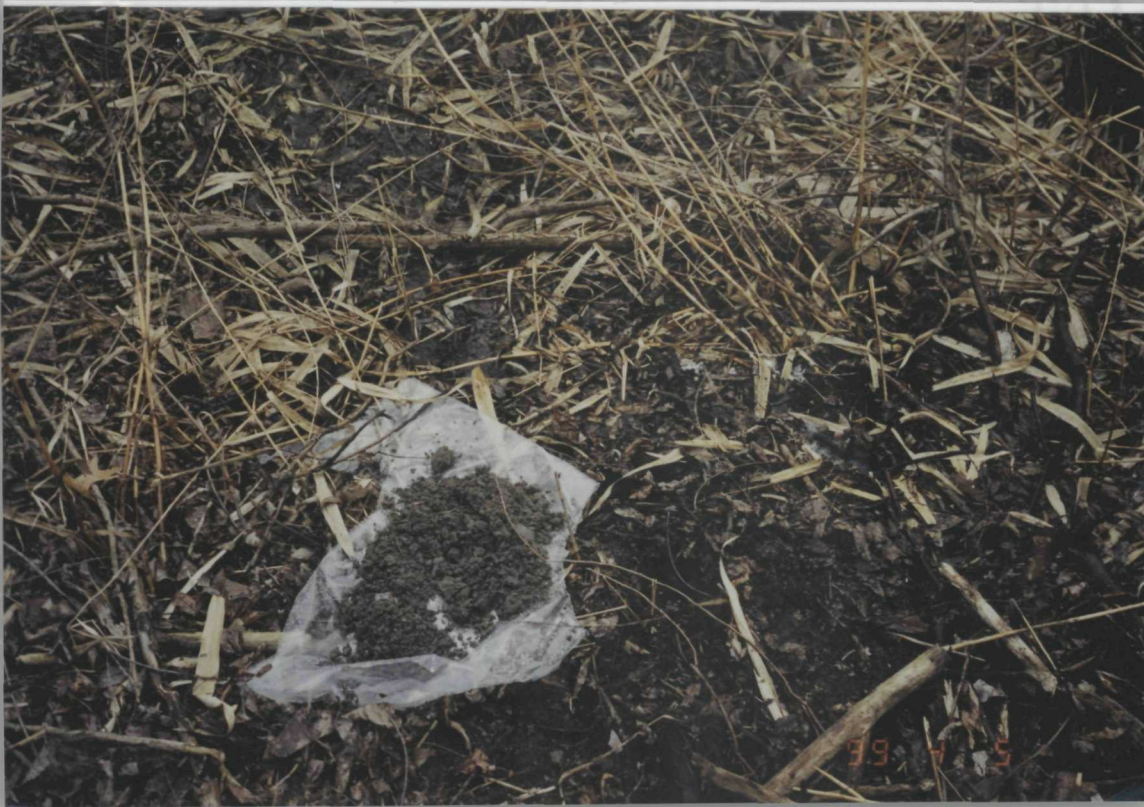
Site: Celotex
Location: Wilmington, IL
Subject: View of sample DEP-3 location.

Date: April 5, 1999
Direction: North

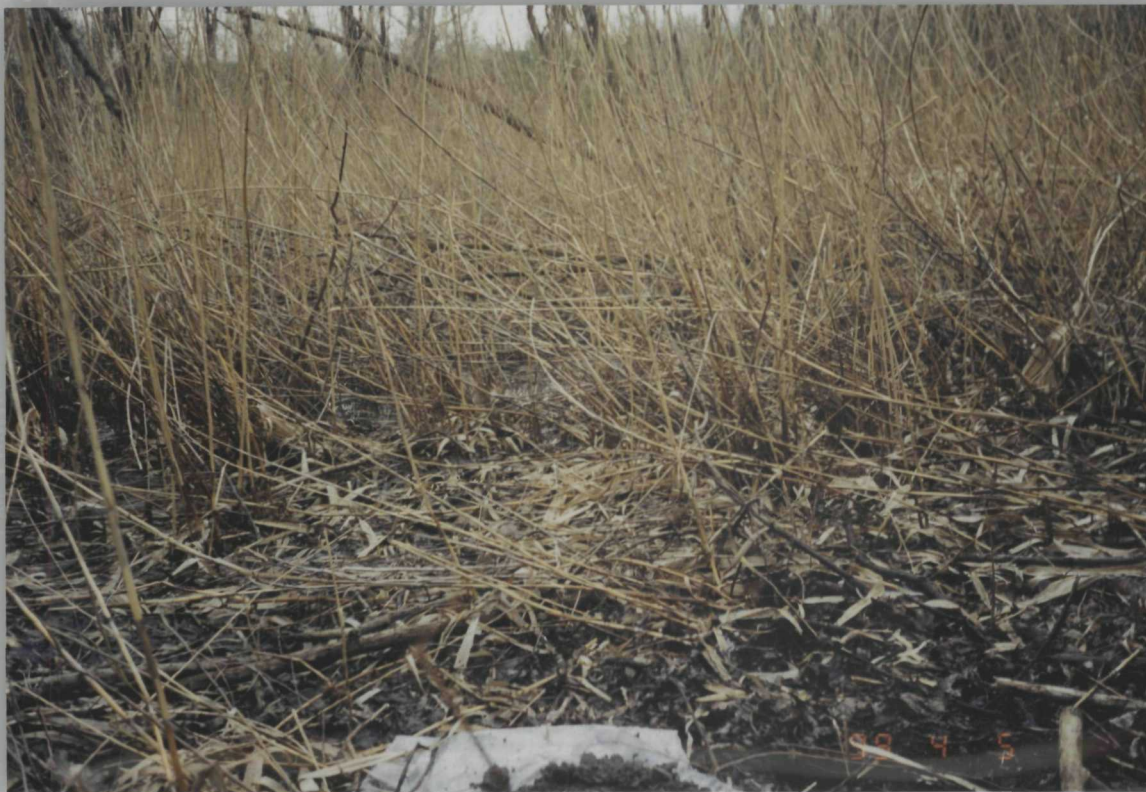
Site: Celotex
Location: Wilmington, IL
Subject: Perspective of sample DEP-3 location.

Date: April 5, 1999
Direction: North

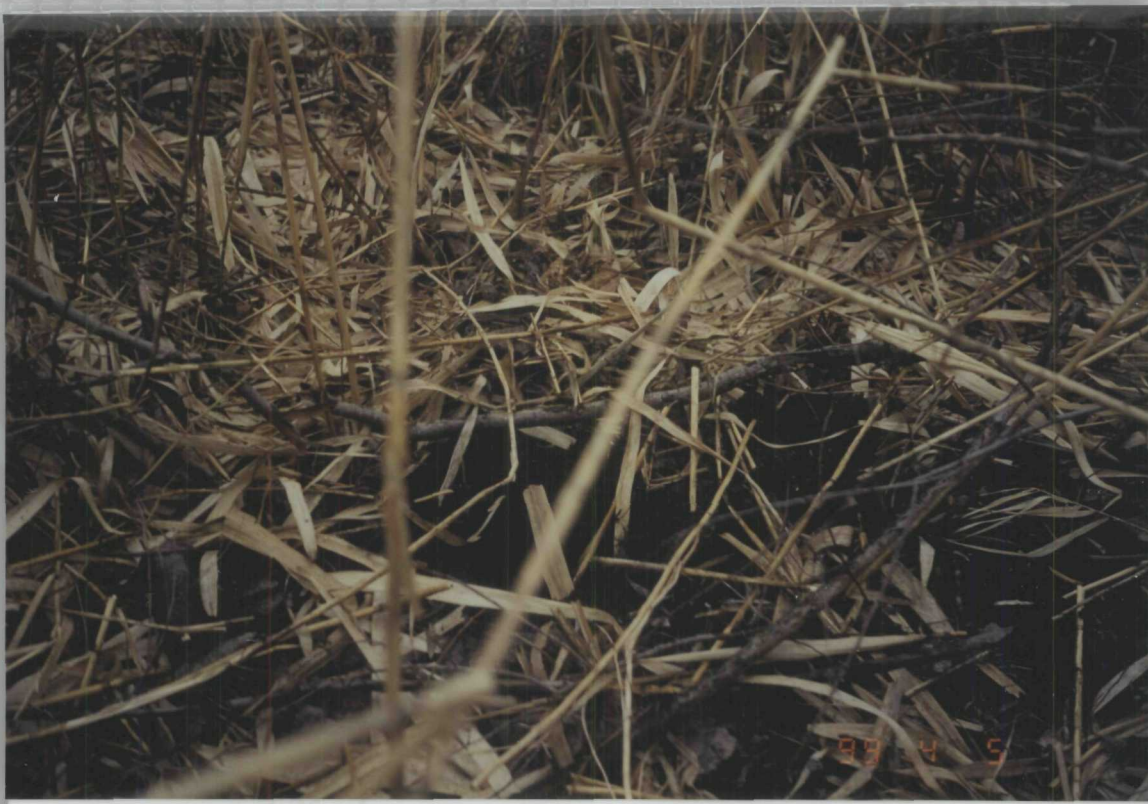
Site:	Celotex	Date:	April 5, 1999	Time:	1510
Location:	Wilmington, IL	Direction:	Southwest	Photographer:	R. Nagam
Subject:	View of sample DEP-4 location.

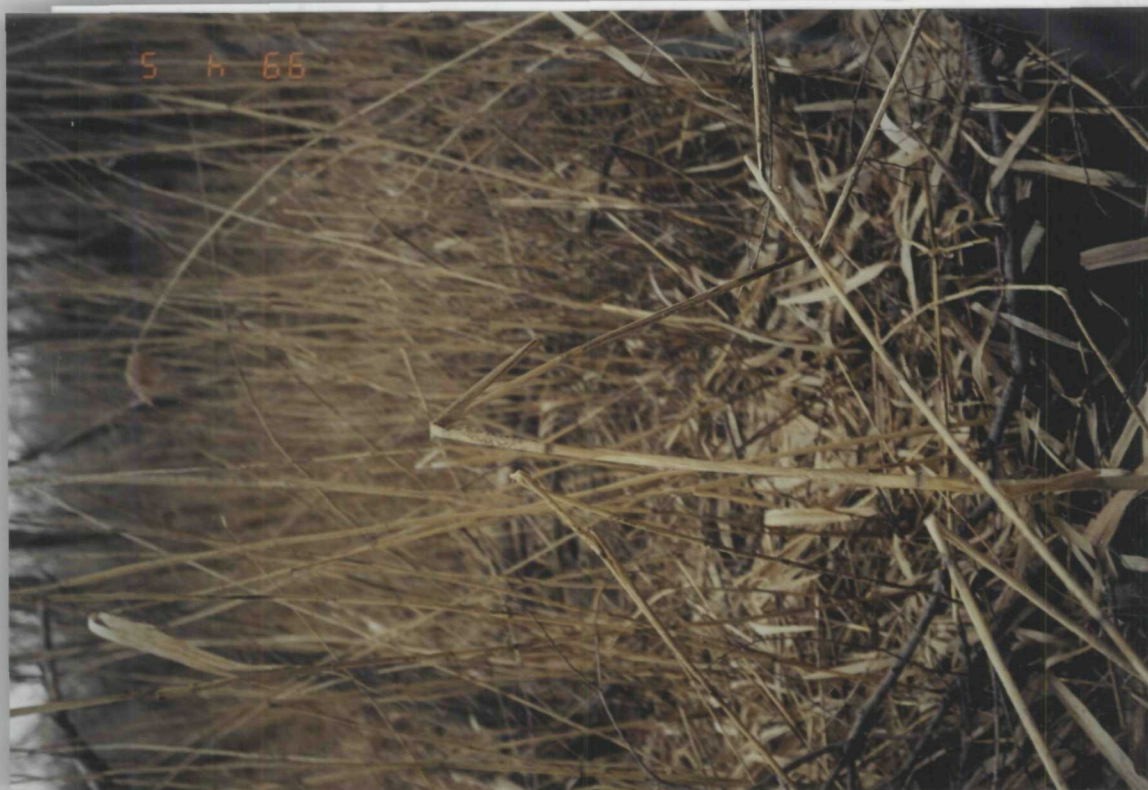
Site:	Celotex	Date:	April 5, 1999	Time:	1510
Location:	Wilmington, IL	Direction:	Southwest	Photographer:	R. Nagam
Subject:	Perspective of sample DEP-4 location.
